# **INVESTIGATION OF BEST OPTIONS FOR USING SCRAP TIRES IN HIGHWAY NOISE BARRIERS**

**June 2011**

**COLORADO DEPARTMENT OF TRANSPORTATION**  
**DTD APPLIED RESEARCH AND INNOVATION BRANCH**

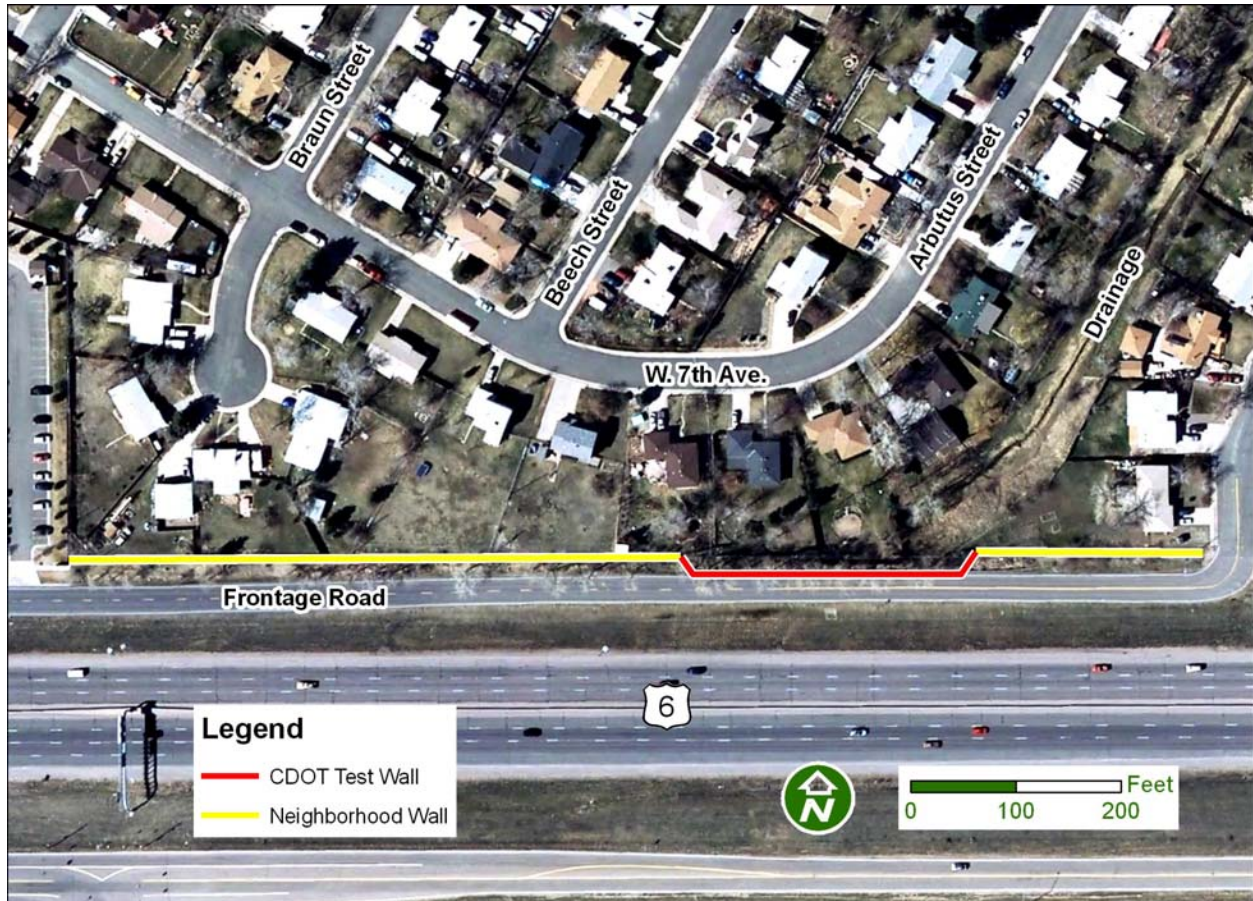
**Figure 1. Overview of CDOT Barrier Test Location**

Once the barrier material was selected in Task 1, a noise barrier wall was designed for the designated project test site along the US 6 (W. 6th Avenue) Frontage Road near Arbutus Street and 7th Avenue in Lakewood, Colorado (Figure 1). The barrier design needed to accommodate both the structural characteristics of the selected barrier material as well as the unique physical characteristics of the site. The resulting design drawings were part of the bid-letting package used by CDOT to select a contractor to build the test barrier and to guide construction of the barrier (Task 3).

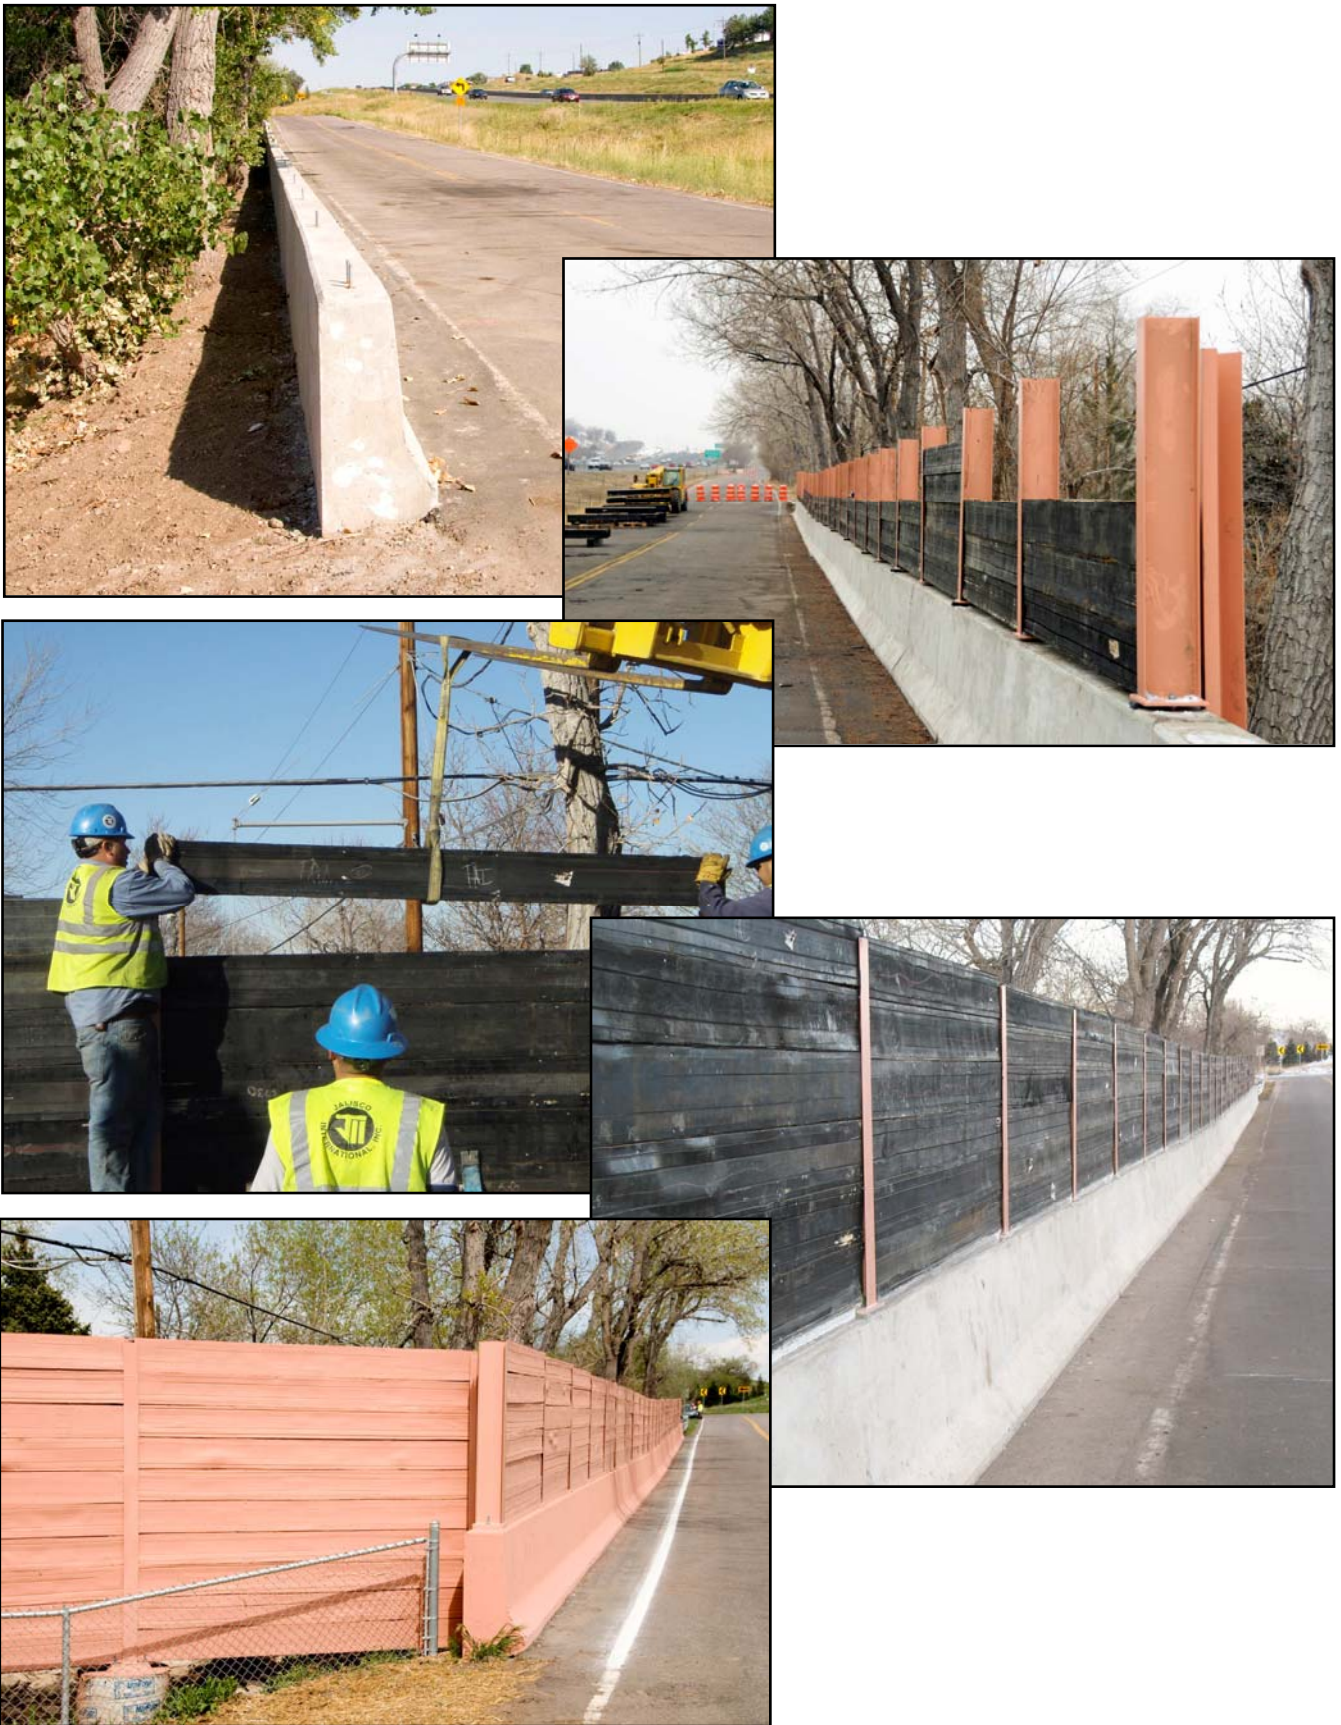
**Figure 3. Construction of CDOT Barrier Wall**

Construction of the barrier wall design from Task 2 was completed by the contractor in conformance with the project specifications. The barrier design was based on the common post-and-panel configuration. The contractor prepared the site for construction, drilled and poured caissons, poured a Type 7 crash barrier base, installed steel I-beam vertical supports, installed Tire-Ties™ between the vertical supports and applied a finish stain to the wall (Figure 3). The Type 7 crash barrier was constructed in August 2009. The majority of the wall was assembled in January 2010. The final stain finish was completed in April 2010 to accommodate the minimum weather requirements for the stain. (Note: the stain was applied so that CDOT's wall would have a color similar to the surrounding neighborhood walls rather than the black of the tire rubber.)

The ongoing monitoring consisted of quarterly site visits for one year (May 2010 to May 2011) with documentation of barrier condition. While the entire test barrier was examined each quarter, two of the 32 barrier panels were selected for closer scrutiny (Panels 2 and 17) during each monitoring period to represent performance of the barrier in general. Panel 2 was an end panel (east end) that represented the panels with no external support and relied on their own internal strength to maintain the barrier structure (Figure 4). Panel 17 was near the center of the barrier and represented the panels consisting of six ties stacked on the Type 7 concrete barrier base (Figure 3) that made up the majority of the barrier.

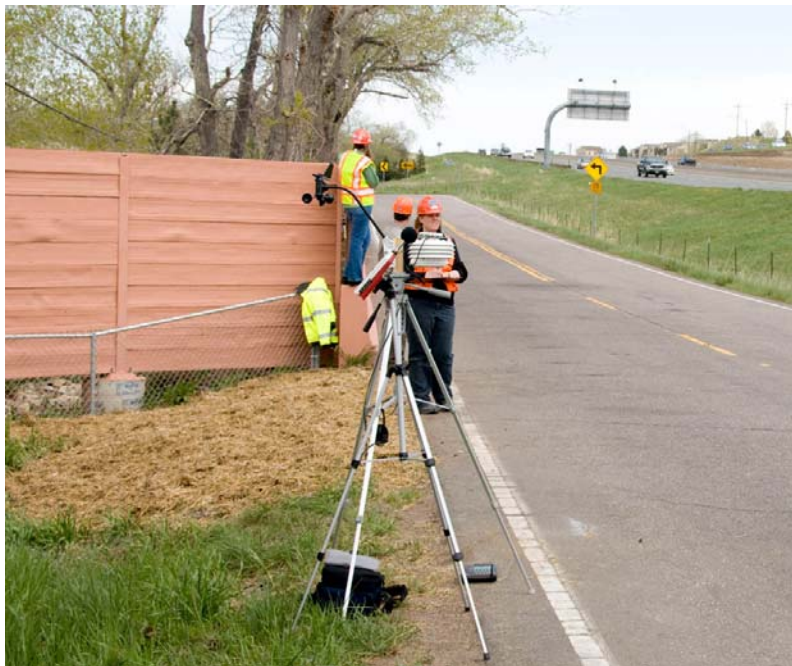
**Figure 4. Measurement of Barrier Noise Reduction (Looking East)**

The measurement of barrier insertion loss was a one-time event shortly after completion of the barrier. The noise-reducing performance of the selected material (Tire-Tie™) was reviewed through concurrent sound-level measurements both in front of and behind the project barrier. The first location (in front of the barrier) faced US 6 with no mitigation of traffic noise (Figure 4). The second location was immediately (less than two feet) behind the project barrier approximately five feet above ground and was protected from US 6 traffic noise by the project barrier.

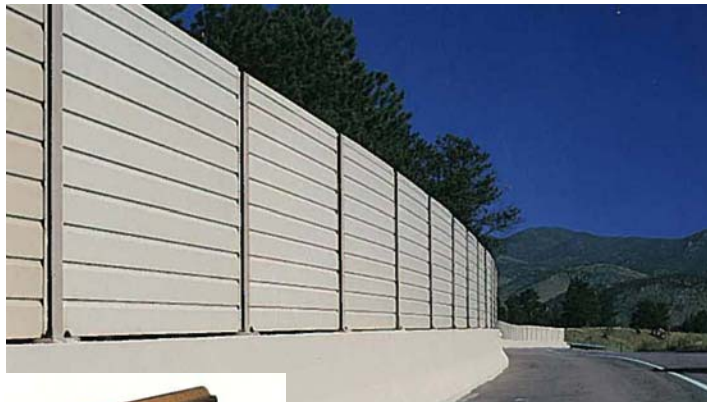
#### 6.1.1 Carsonite AcoustaShield™

In a new process, scrap tire waste can be used in combination with a structural element to create an aesthetic, functional, and long-lasting barrier wall. The recycled scrap tire core consists of a mixture of several crumb rubber sizes and a phenolic binder. A ten-foot-high, one-mile-long wall would consume approximately 250,000 pounds of scrap tires.

The structural element, shaped into a tongue-and-groove building plank, is a fiberglass-reinforced plastic composite that has consistent and predictable mechanical properties with an expected life cycle of 50 years. The glass-reinforced plastic contains flame retardant, is self-extinguishing, and is protected by ultraviolet inhibitors to prevent solar degradation. The tongue-and-groove structural element is manufactured by a continuous process that ensures high quality and structural soundness to meet the load-bearing requirements of the sound wall.

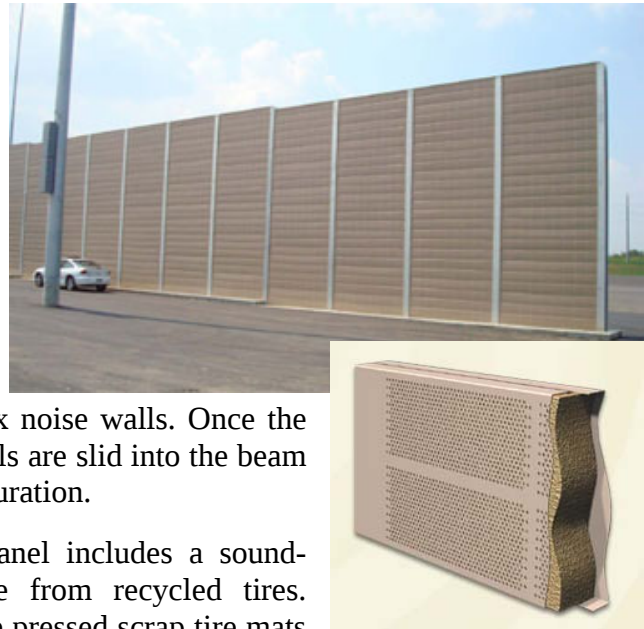
The conventional design of an Acoustax panel includes a sound-absorbing filler material that is not made from recycled tires. However, the design could be modified to use pressed scrap tire mats as the filler material.

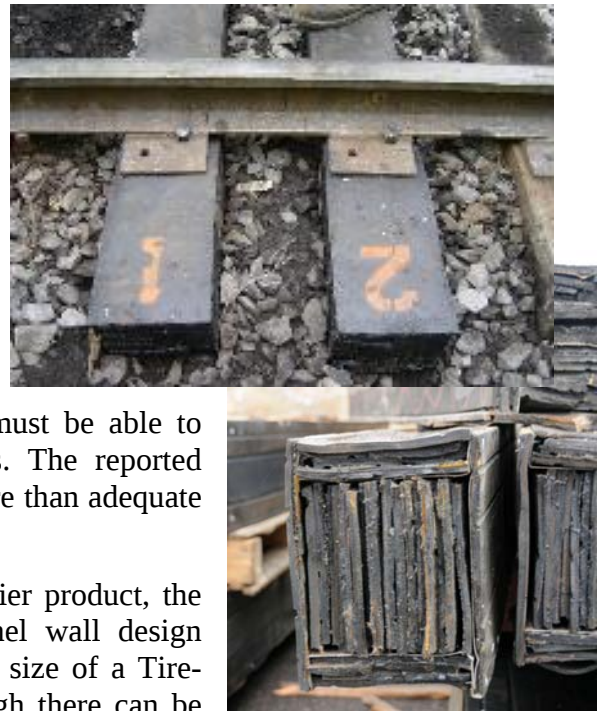
Although not originally developed as a noise barrier product, the Tire-Tie™ is easily adapted into a post-and-panel wall design typical of other noise wall products. The nominal size of a Tire-Tie™ is 7 inches by 9 inches by 8.5 feet, although there can be flexibility with the final dimensions, particularly with length. The Tire-Tie™ design uses approximately 23 tires per tie.

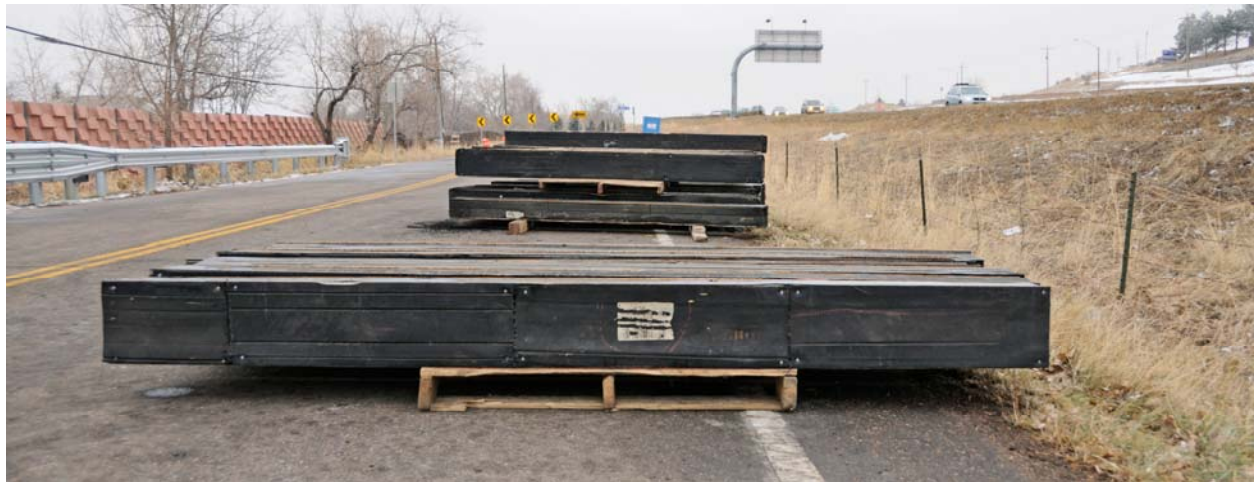
**Figure 5. Tire-Ties™ Staged for Construction**

The barrier was built successfully, with the final construction activities (staining) in April 2010. Insertion of the Tire-Ties™ (Figure 5) into the wall panels was completed in two days. The ties proved to be relatively easy to handle during construction.

Each Tire-Tie™ (Figure 5) ultimately cost the project \$250, which was more than originally anticipated. Several factors contributed to this. The supplier was still a start-up company and did not have personnel, supplies or production facilities to mass produce the Tire-Ties™ at the time. CDOT’s order was reported to be the largest in their history to that point. The manufacturer has reported a desired price point of approximately \$100 to \$125 per Tire-Tie™, to be cost-competitive with the wooden railroad ties they are intended to replace. If this pricing goal is

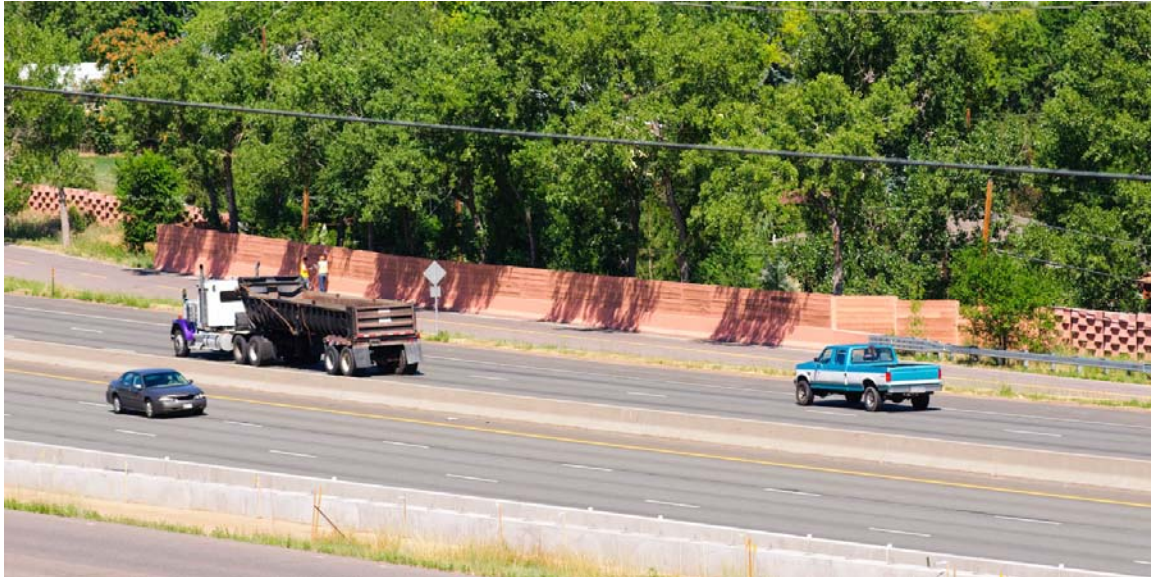
**Figure 6. Completed CDOT Barrier Wall from US 6 Side**

This task consisted of two primary subtasks: evaluate the noise-blocking performance of the chosen barrier material in the finished barrier wall (Figures 6 and 7) and assess generally the physical performance of the barrier material for one year. These were achieved through a combination of quantitative sound level measurements and qualitative observations.

Subtracting the measured noise levels (Section 5) resulted in the project barrier providing approximately 7.8 dBA of insertion loss immediately behind the barrier. This noise reduction is well within the CDOT goal of noise reduction of 5-10 dBA and is noticeable behind the wall (4). This result was affected by several site conditions, including:

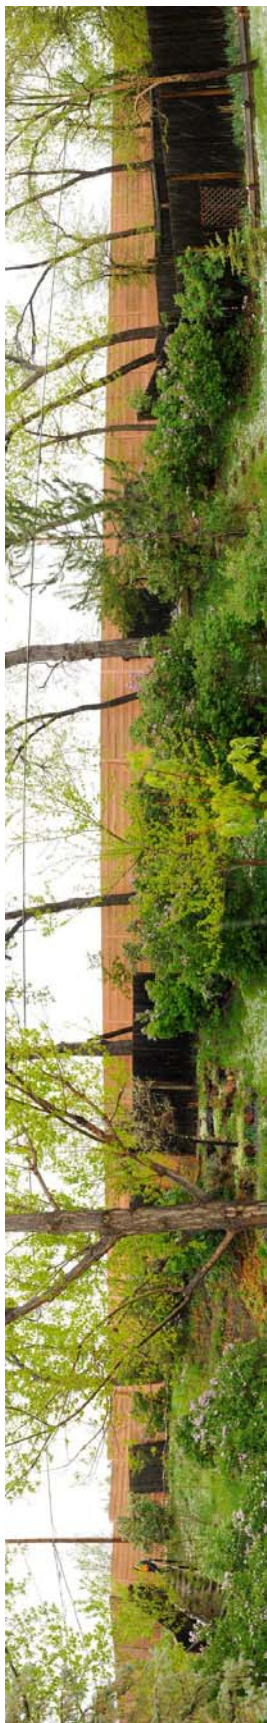
**Figure 7. Completed CDOT Barrier Wall from Neighborhood Side**

- ▶ Approximately 2.5 feet of barrier “free board” was present above the sound meter during the measurement and was affected by the amount of noise refraction over the top of the barrier.
- ▶ The Tire-Ties™ were intentionally stacked loosely on top of each other within the vertical I-beam supports for this project. Though the faces of the stacked Tire-Ties™ did fit together well, not all of the joints mated perfectly, so occasional small gaps between Tire-Ties™ were present. This was a minor effect, but sound can pass through these gaps. Such gaps could be closed, such as with caulking between ties.

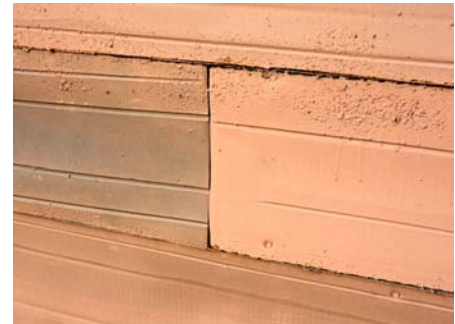
The Tire-Ties™ were manufactured with steel and rust appeared on some of the exposed steel (Figure 8). This will be primarily an aesthetic issue. The rust was similar in color to the finish stain, but it is visible. It is unknown how this will progress over the life of the wall.

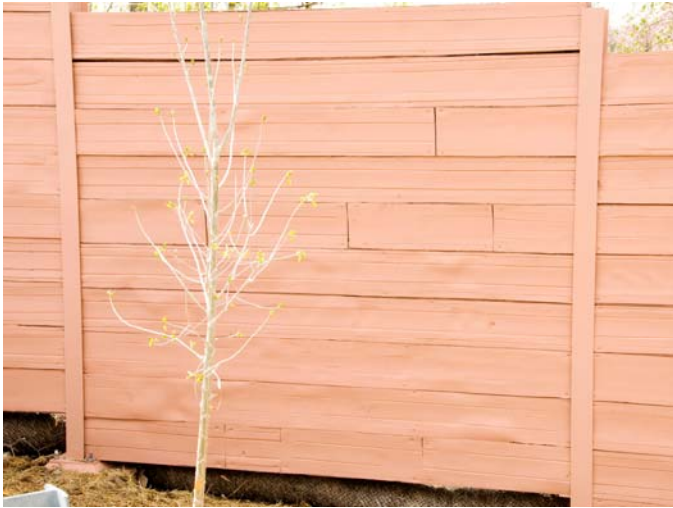
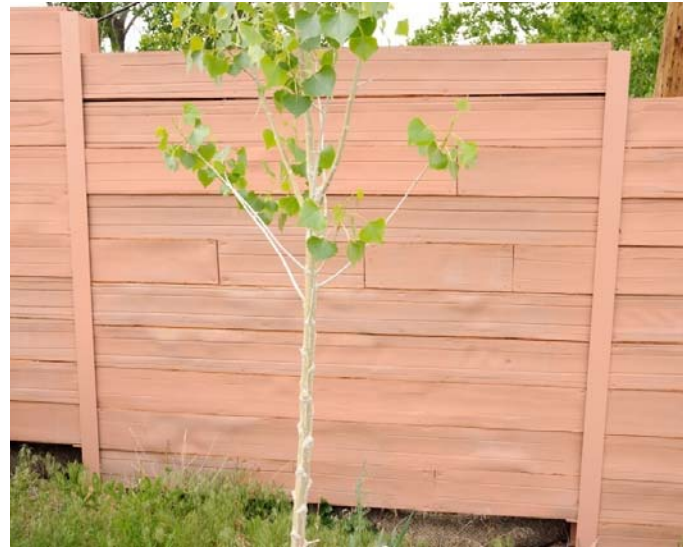
Wall Panel 2

The Tire-Ties™ were not designed to be a visually refined product to fulfill their primary purpose with the railroads. Consequently, the manufacturing tolerances allowed for imperfections that were visible when the ties are used in a noise wall. For instance, some of the surficial tire treads contained “bubbles” (photo at right) and other visual breaks. This was an aesthetic consideration that did not affect the integrity of the wall and did not change noticeably during monitoring.

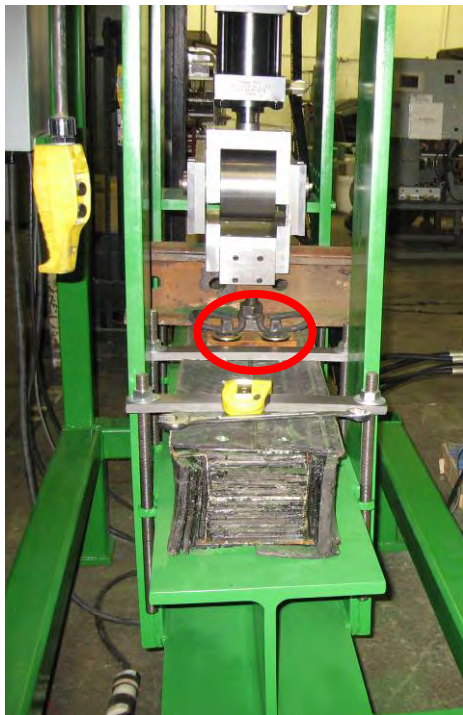
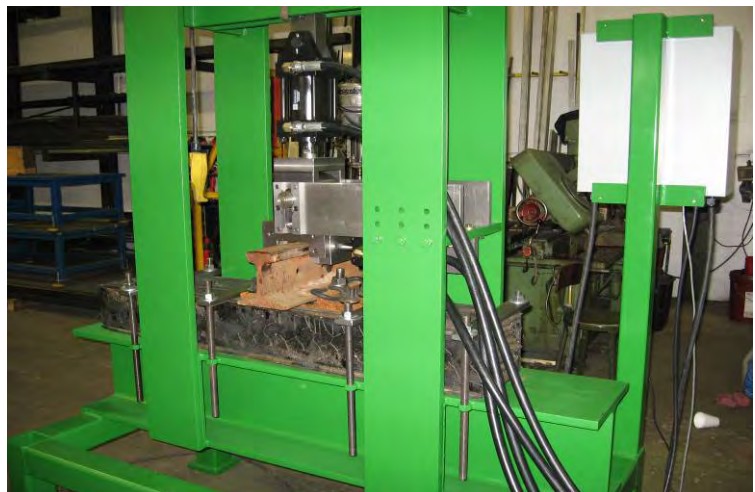
**Figure 1:** NP&G TireTie™ Lateral and 3-Point Bend Fixture

This fixture with simple modifications also can apply a load to the center of the cross tie in a 3-pt bend configuration.

The 3 point bend test was performed on the NP&G cross tie test fixture depicted in figure 1. The crosstie under test was supported by two plastic blocks 60 inches apart with a vertical load applied centered between the two blocks. Figure 4 below shows the support and loading configuration.

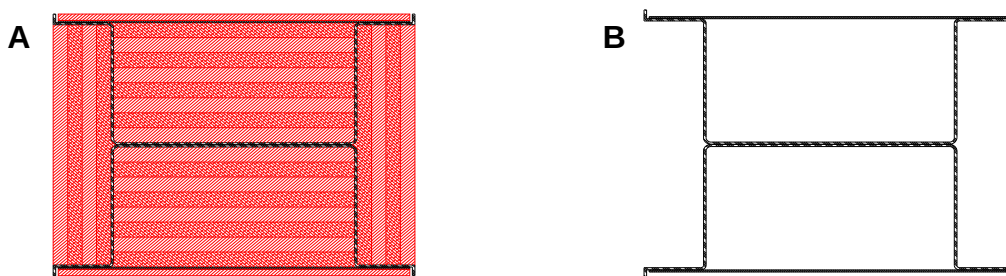
**Figure 2:** NP&G Tire tie crosssection with tire tread laminates (red) (A) and with tread laminates removed showing only the steel webbing. (B)

Note, there were multiple NP&G composite crosstie configurations. All NP&G crossties were steel and tire tread laminate composites, see figure 3 below for crosssection details.

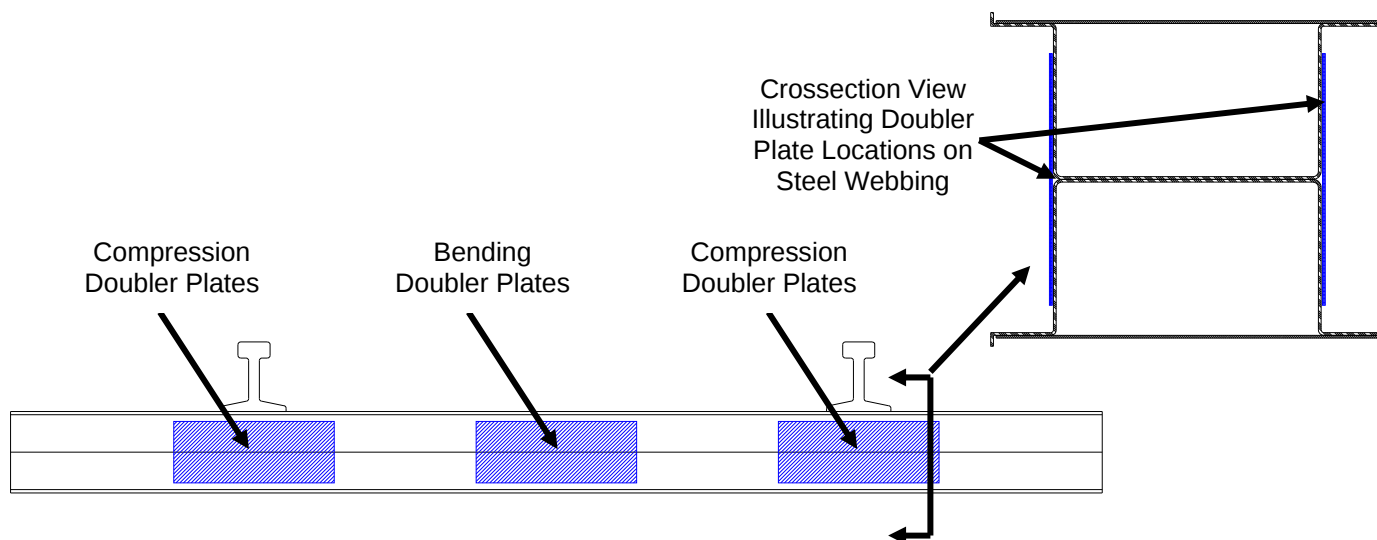
**Figure 3:** Illustrations of NP&G Tire Tie doubler plate locations.

Further, the NP&G composite cross ties were also tested with and without “doubler plates”. The doubler plates are 15" x 5-7/8" 12 gage plates welded to specific regions of the crosstie’s steel webbing prior to installation of tread laminates. Figure 4 below depicts the doubler plate locations.

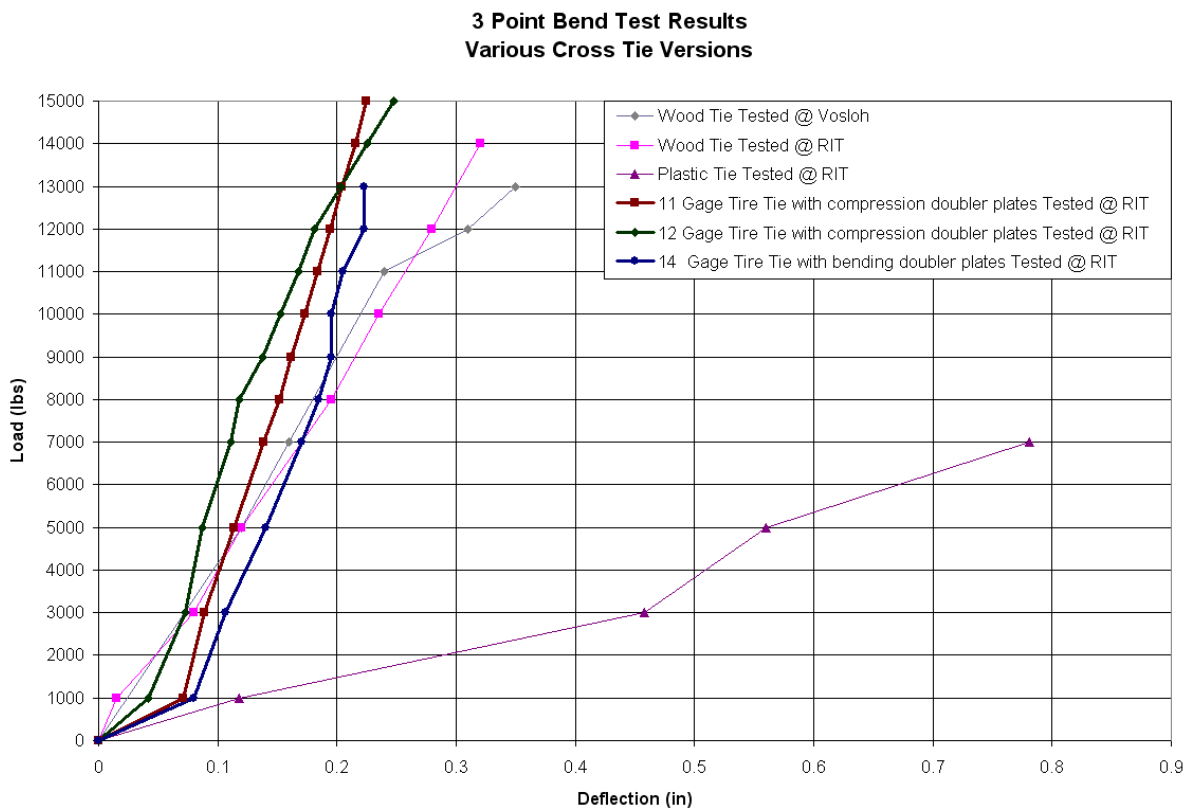
**Figure 5:** Three Point Bend Results all deflections in inches.

Figure 5 also shows that the NP&G cross ties had the least deflection per given load and the plastic tie had the most deflection. The 3-point bend test performed on the plastic tie was stopped after deflecting 0.78" at a loading of 7000lbs.

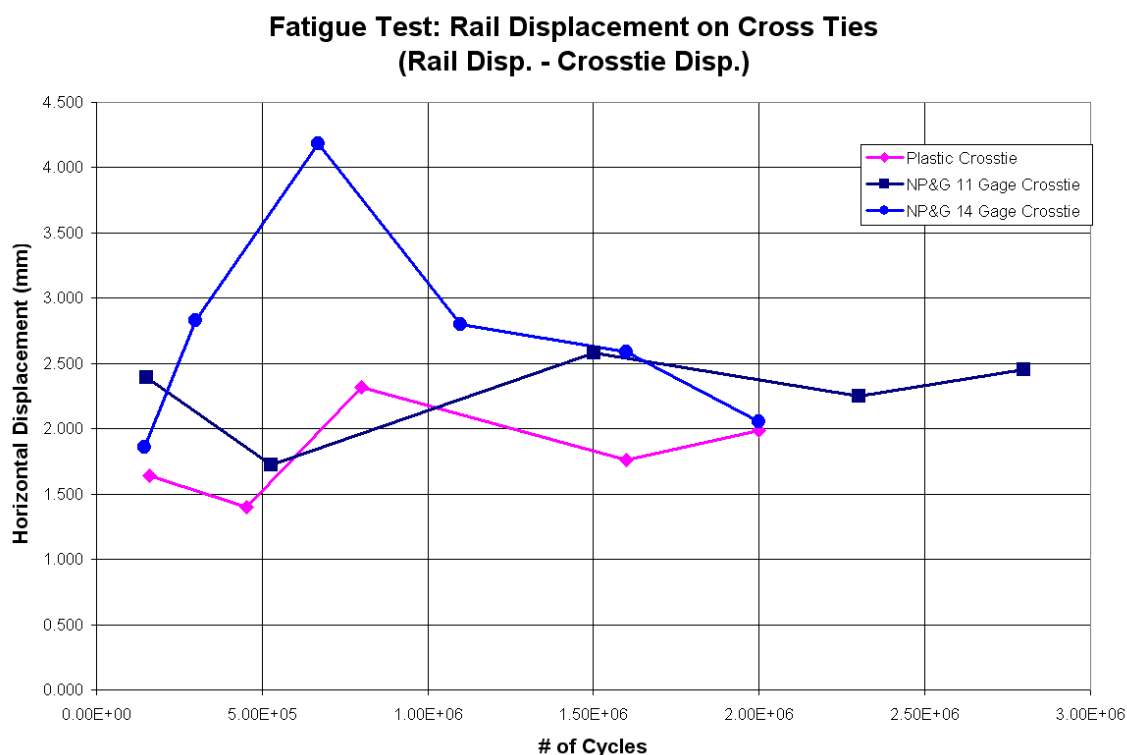
**Figure 9:** Fatigue test results (deflection of top of rail – deflection to the cross tie top surface) for the two configurations of the NP&G composite cross tie and the plastic cross tie.

The results for the laser displacement measurements are illustrated in Figures 9, and 11 as well as tables 2 and 3.

Figure 8 depicts the shear loading that is induced on a crosstie due to lateral loading of the rail during test. Figure 9 shows the amount of displacement or shear from the top of the rail to the bottom (assuming no slip at the bottom of the crosstie).

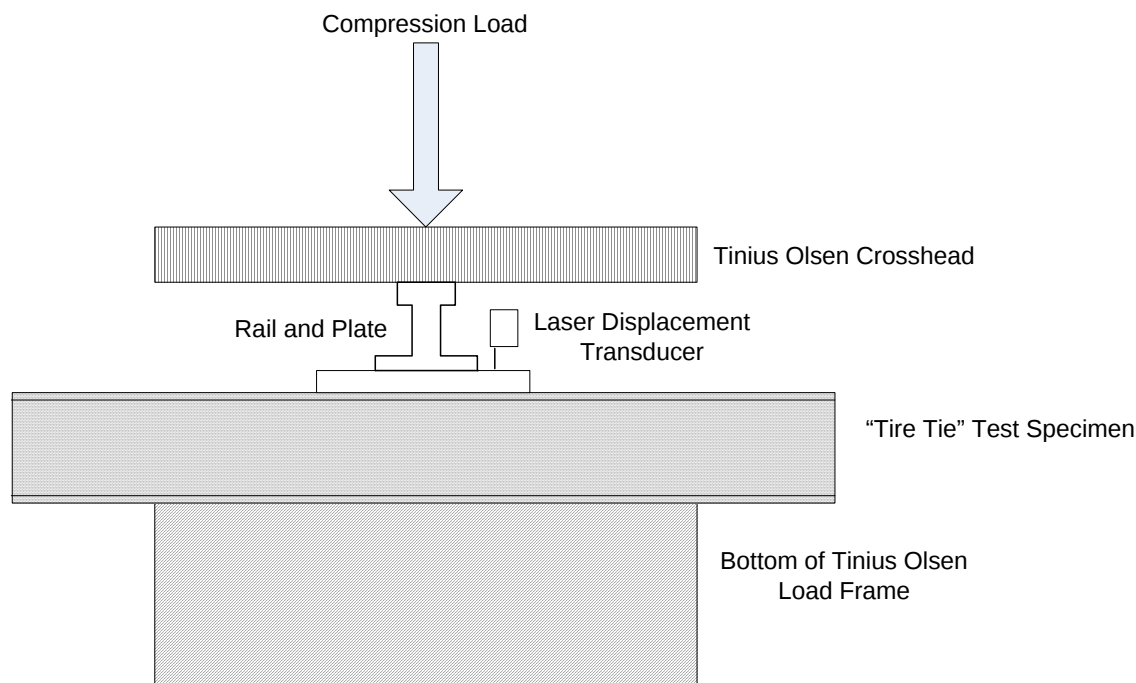
**Figure 12:** Compression test setup

Figure 12 below depicts the test apparatus setup. In this evaluation, a Tinius Olsen Compression Test Apparatus was used to apply the required test loads.

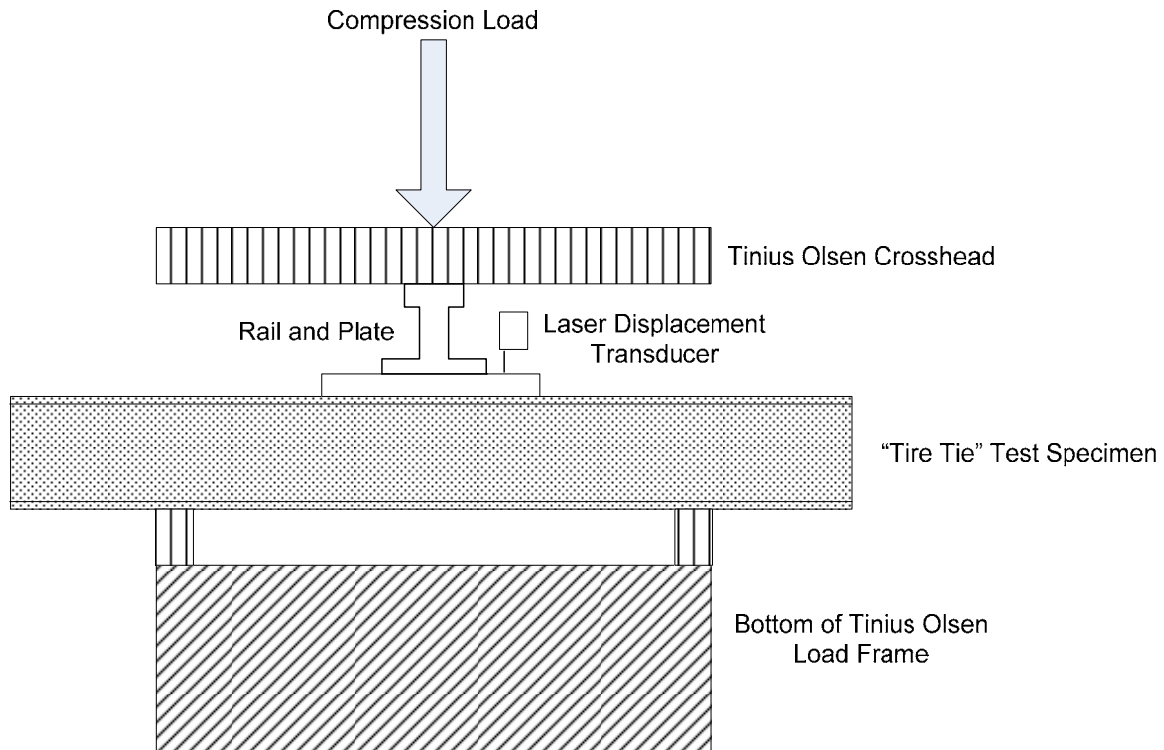
**Figure 14:** Test setup for MOR evaluation using the Tinius Olsen compression tester.

Modulus of rupture also known as flexural strength, bending strength or fracture strength is typically measured in terms of stress. The value is the highest stress experienced within the material at its moment of rupture. A common method of performing a MOR test is to continue a 3 point bend test until the specimen fails. For this evaluation MOR testing consisted of vertically loading a cross tie while it was simply supported on its bottom surface.

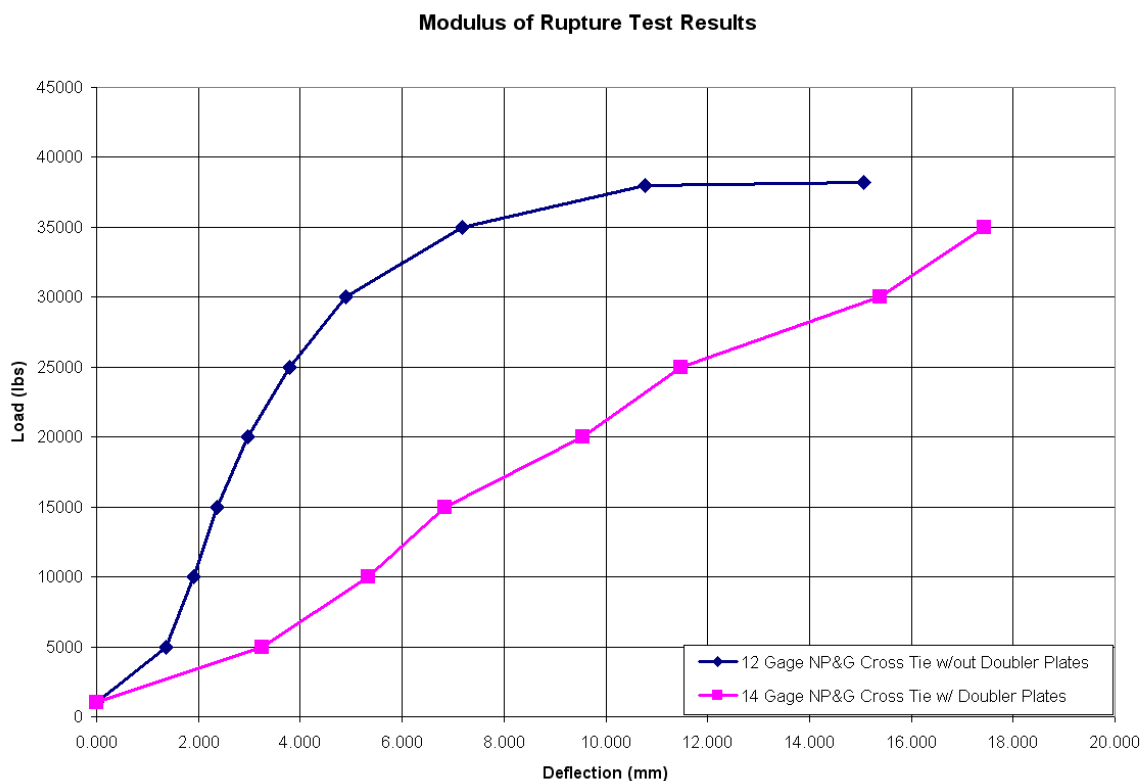
**Figure 15:** MOR test results for the NP&G 12 and 14 gage composite cross ties.

Figure 15 below illustrates the results of the two MOR tests.

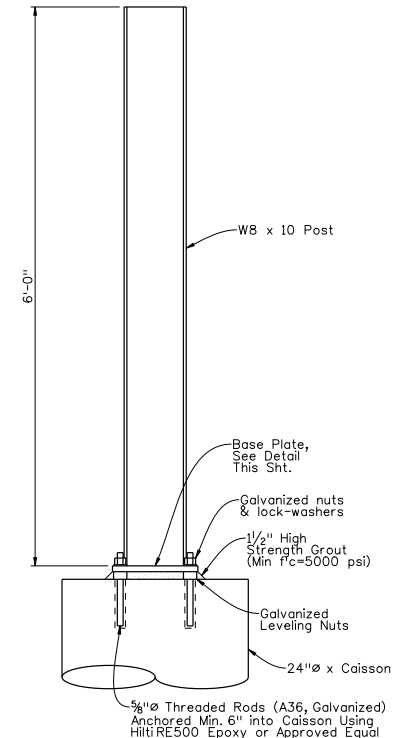
**CLOSURE PANEL POST DETAIL**

Note: Adjust Post locations on Caissons as required to fit Tire Tie panels. Posts may be centered up to 2" away from center of Caisson in any direction.
